Subject:
Former Plainwell Impoundment 2010 Bank Conditions Monitoring Report
Allied Paper, Inc./Portage Creek/Kalamazoo River Superfund Site

SEDIMENTS

**Former Plainwell Impoundment
2010 Bank Conditions Monitoring
Report**

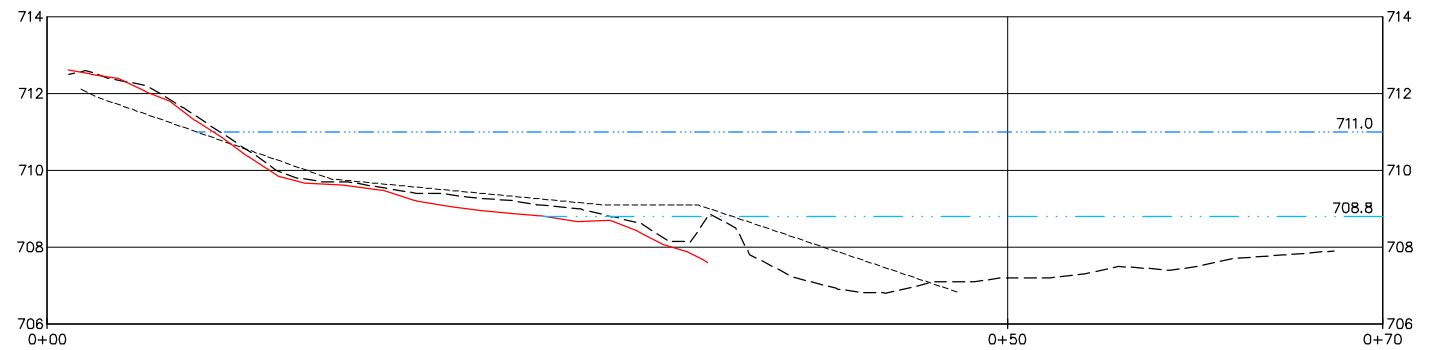
T-4N (NORTH BANK)
SCALE AS NOTED

- T-4N – This transect is located on the north bank in Removal Area 5A. The bank at this location currently appears very similar to the geometry observed in 2009. The 2010 survey did not extend to the toe of slope to enable an assessment of its stability. Overall, this bank is currently characterized as stable.

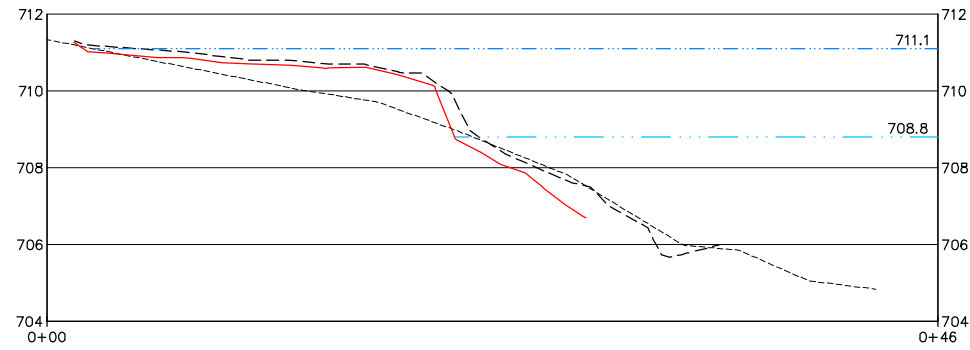
T-4S (SOUTH BANK)
SCALE AS NOTED

- T-4S – This transect is located on the south bank in Removal Area 4B. The accumulation of sediment at the top-of-bank that was observed in 2009 exhibits some slight erosion and bank steepening. The lower portion of the bank exhibits a stable slope but also shows signs of some lateral erosion. The 2010 survey did not extend to the bank toe to enable an assessment of its stability. Overall, this portion of the bank is remaining stable.

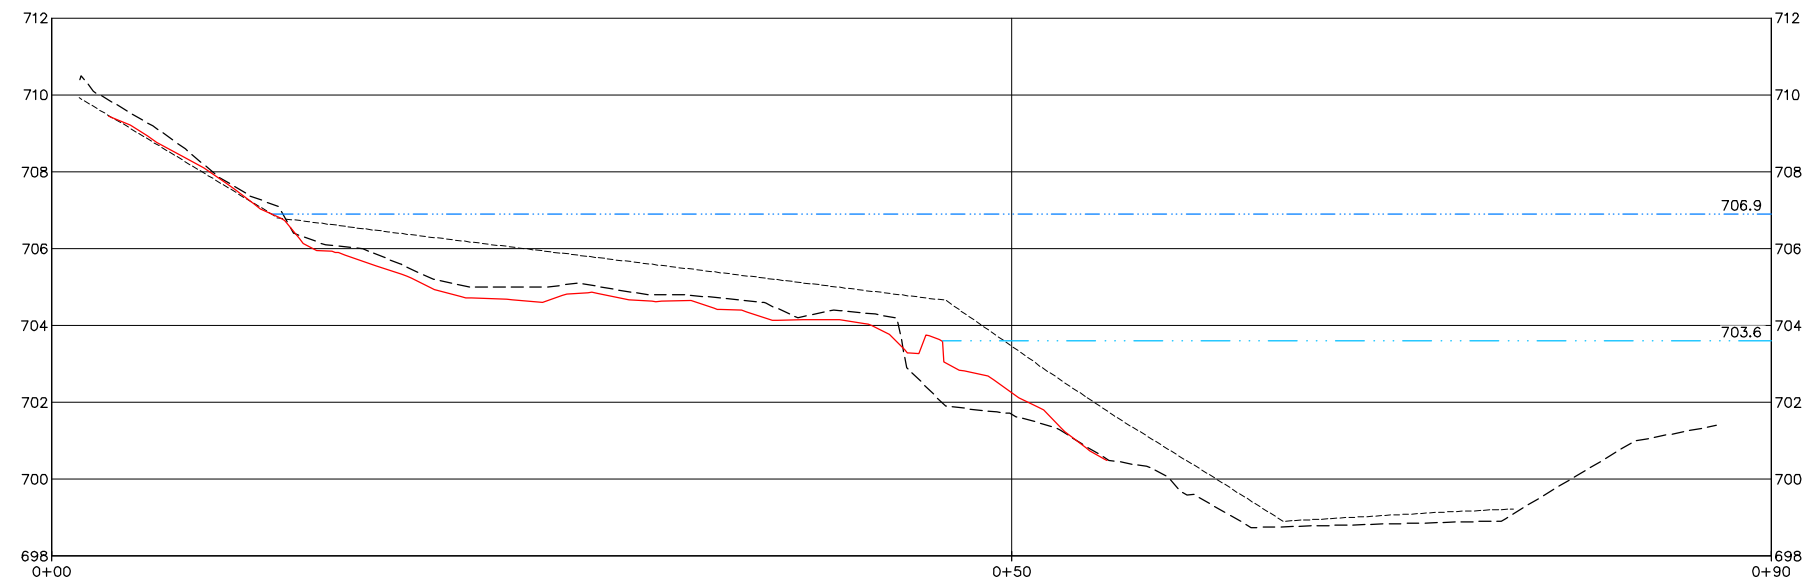
T-8S (SOUTH BANK)
SCALE AS NOTED

- T-8S – This transect is located on the south bank in Removal Area 9B. Some significant erosion was concluded to be occurring at this location in 2009, as evidenced by the loss of the designed slope and a steepening of the bank angle at the median water level. Therefore, this portion of the south bank was repaired in 2009 by the addition of rock at the toe and the installation of a coir log at the prism-out median water elevation to protect the lower bank shelf. The coir log, ~~is visible on the cross-section~~ should assist in the accumulation of sediment on the upper portion of the bank. Following the repair, the portion of the bank immediately below the median water elevation is currently at a stable slope. ~~The coir log should assist in the accumulation of sediment on the upper portion of the bank.~~ This bank is currently characterized as stable.

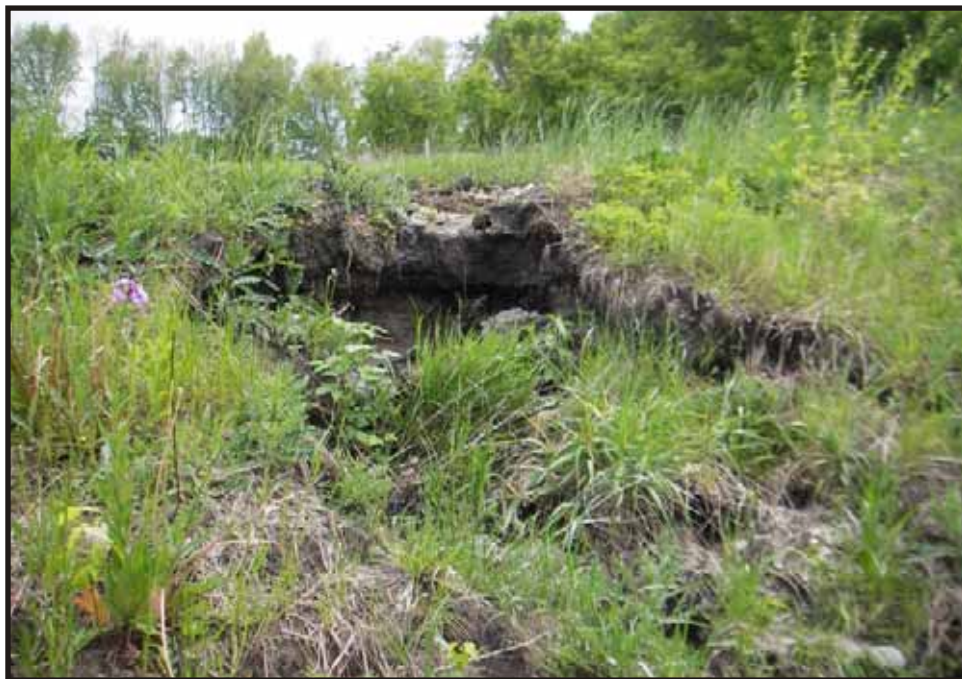
Area of south bank in Removal Area 9B requiring repair.

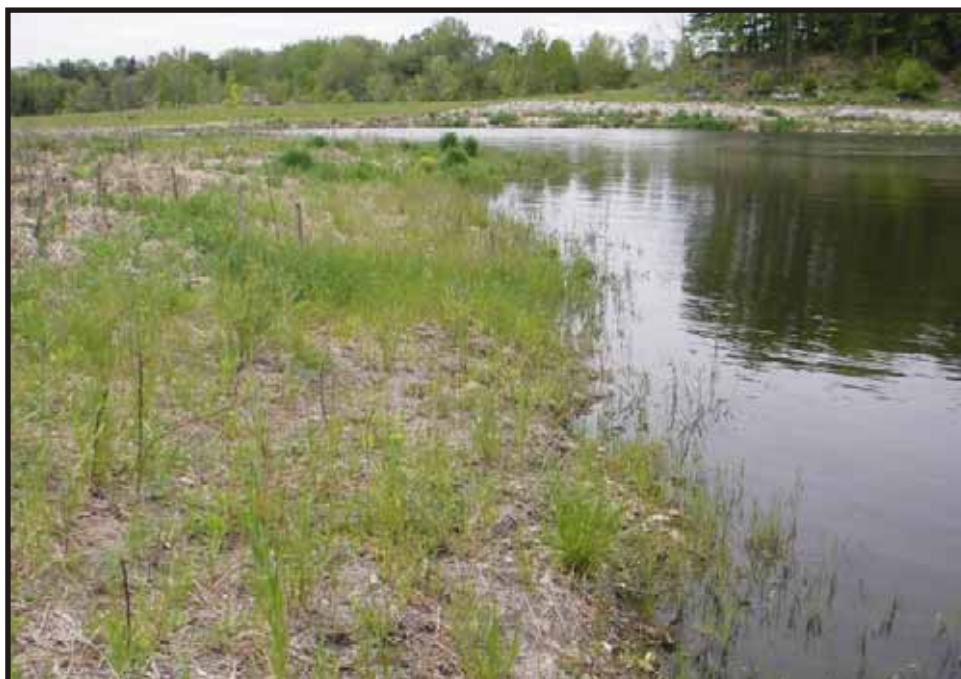
1

Photo #1: BEHI Area B1 (Low Erosion Potential) on north bank upstream of the former Plainwell Dam, looking southwest.

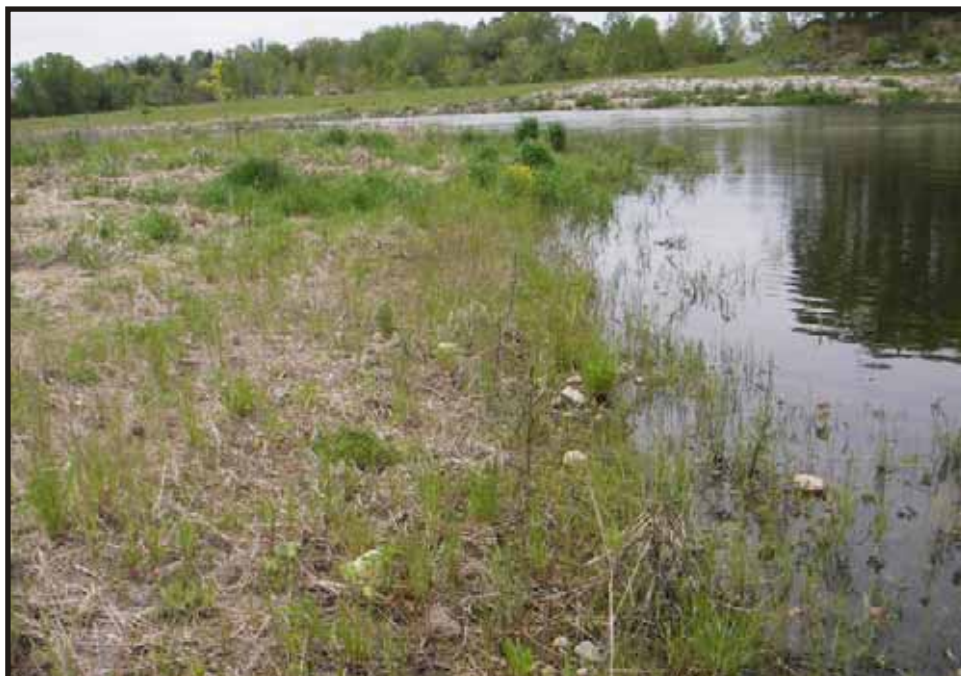
2

Photo #2: BEHI Area C1 (Low Erosion Potential) on north bank upstream of the former Plainwell Dam, looking southeast.

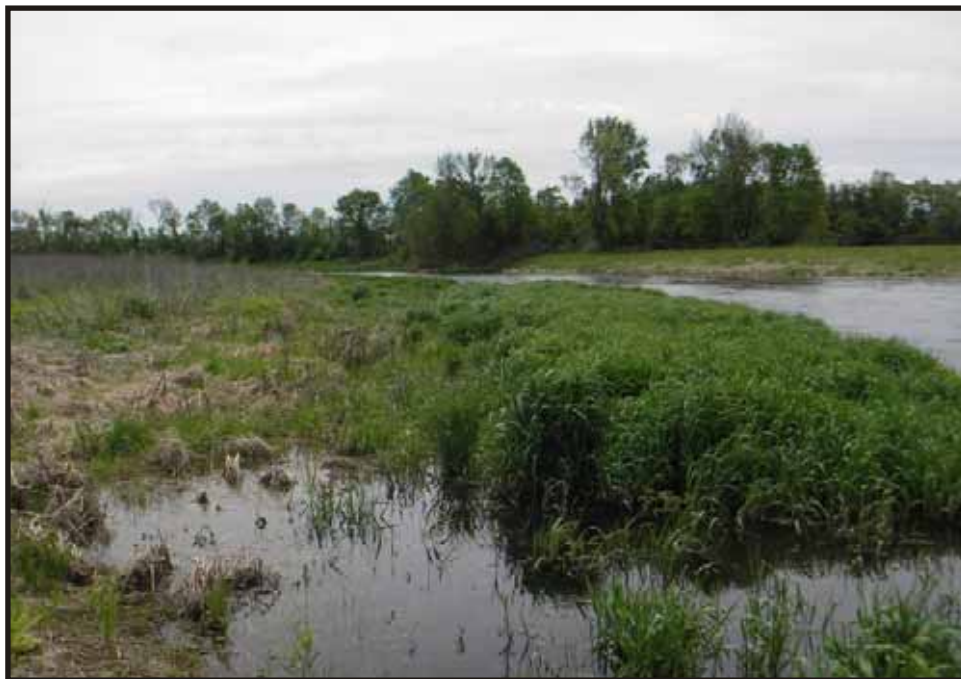
3

Photo #3: BEHI Area D1 (Very Low Erosion Potential) on north bank upstream of the former Plainwell Dam, looking southeast.

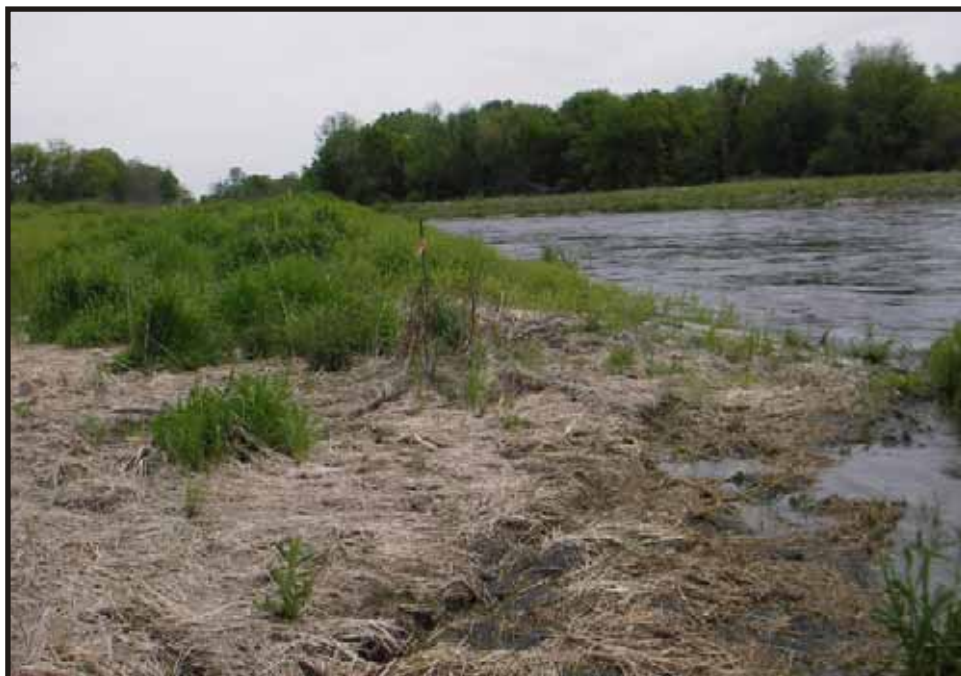
4

Photo #4: BEHI Area D (Very Low Erosion Potential) on north bank upstream of the former Plainwell Dam, looking east.

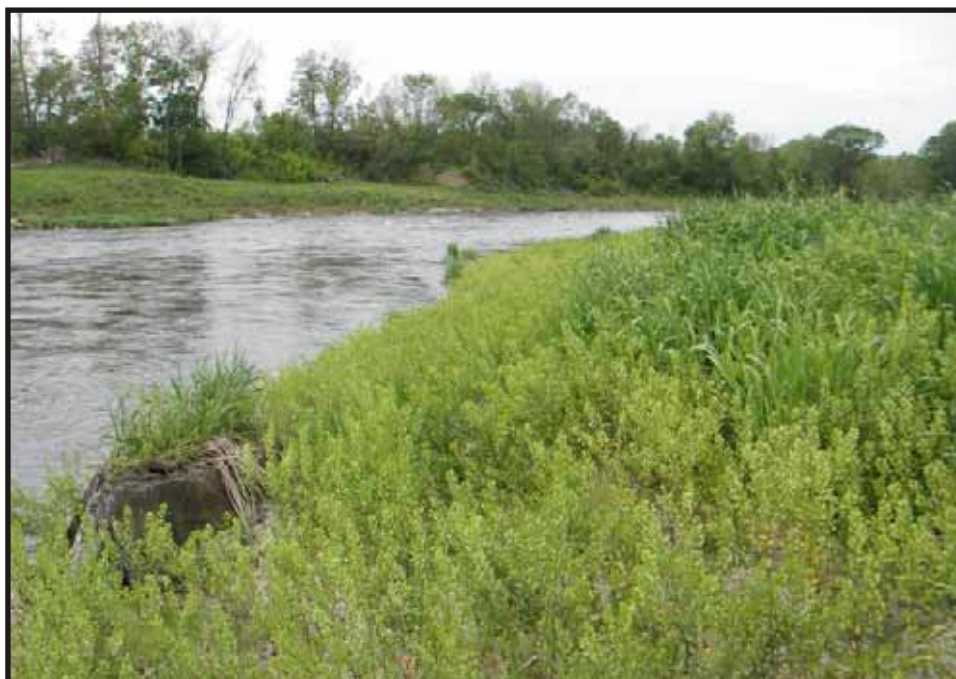
5

Photo #5: BEHI Area E1 (Moderate Erosion Potential) on north bank at the regraded gas pipeline, looking southwest.

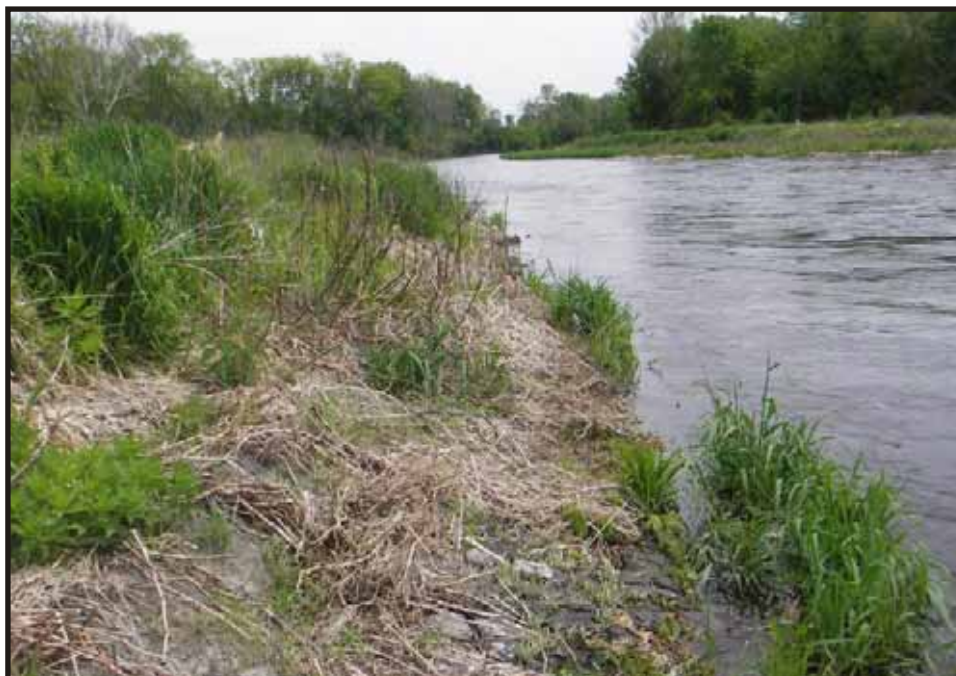
6

Photo #6: BEHI Area G1 (Moderate Erosion Potential) on north bank upstream of the gas pipeline, looking northeast.

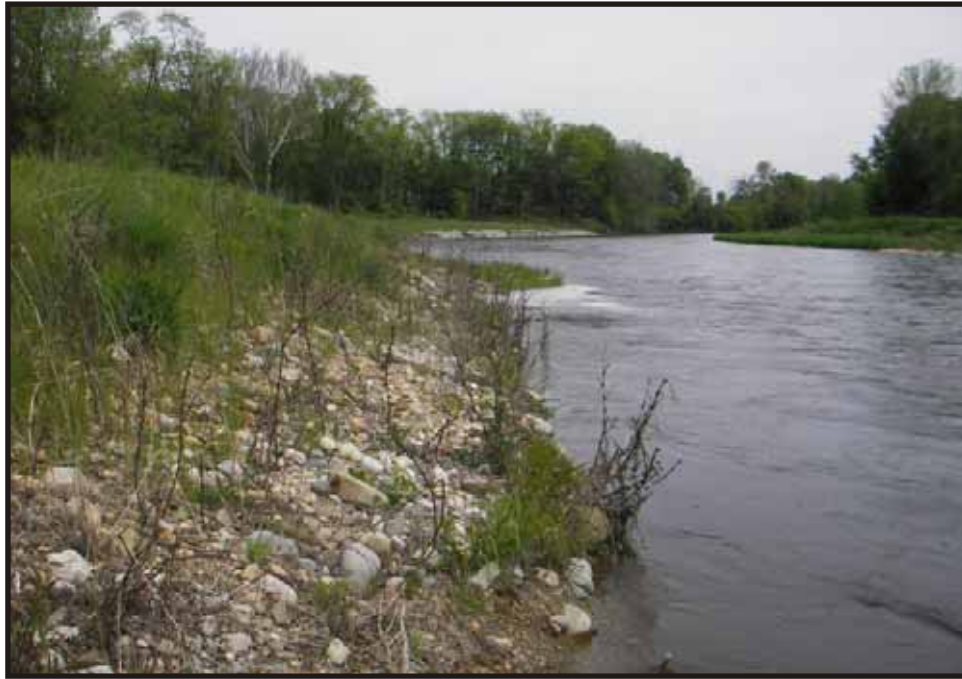
7

Photo #7: BEHI Area H1 (Very Low Erosion Potential) on north bank, looking east.

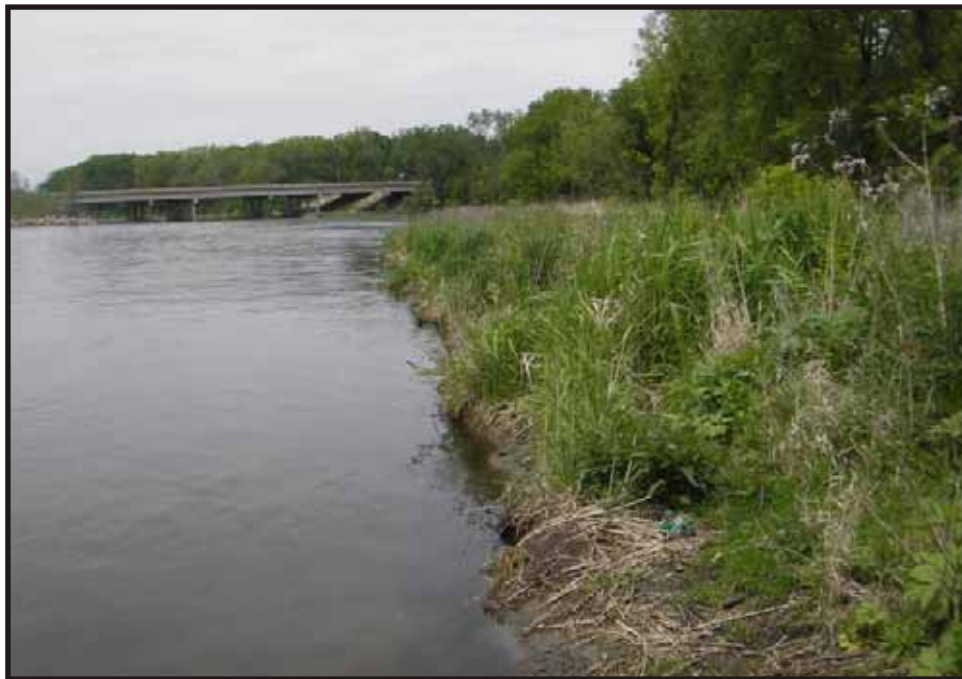
12

Photo #12: BEHI Area I2 (East) (Moderate Erosion Potential) on north bank immediately upstream of the US-131 bridge, looking northwest.

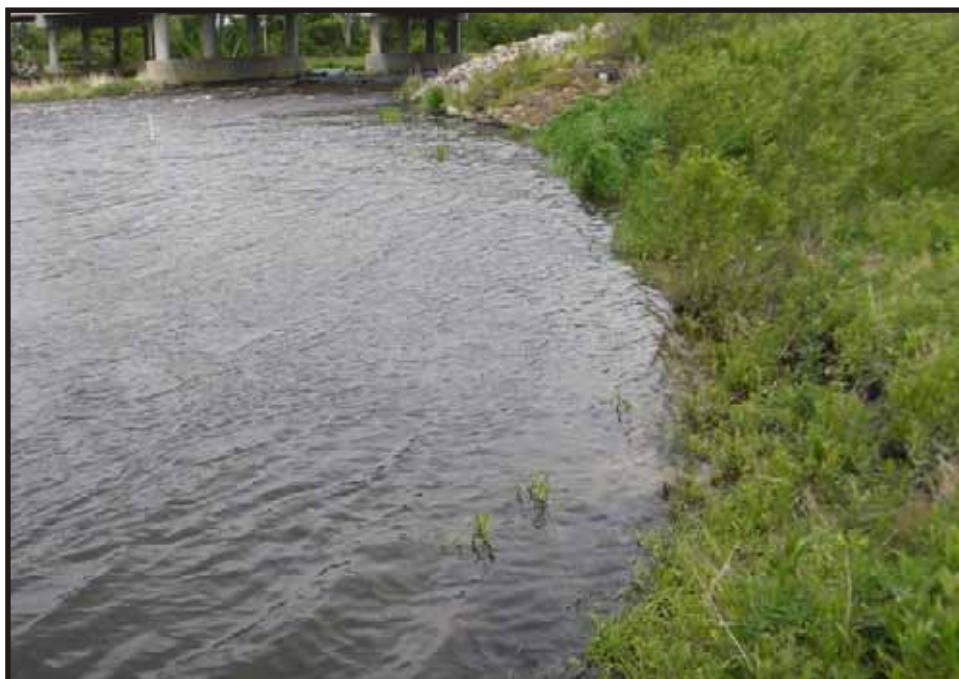
21

Photo #21: BEHI Area A2 (Moderate Erosion Potential) on south bank downstream of the US-131 bridge, looking southeast.

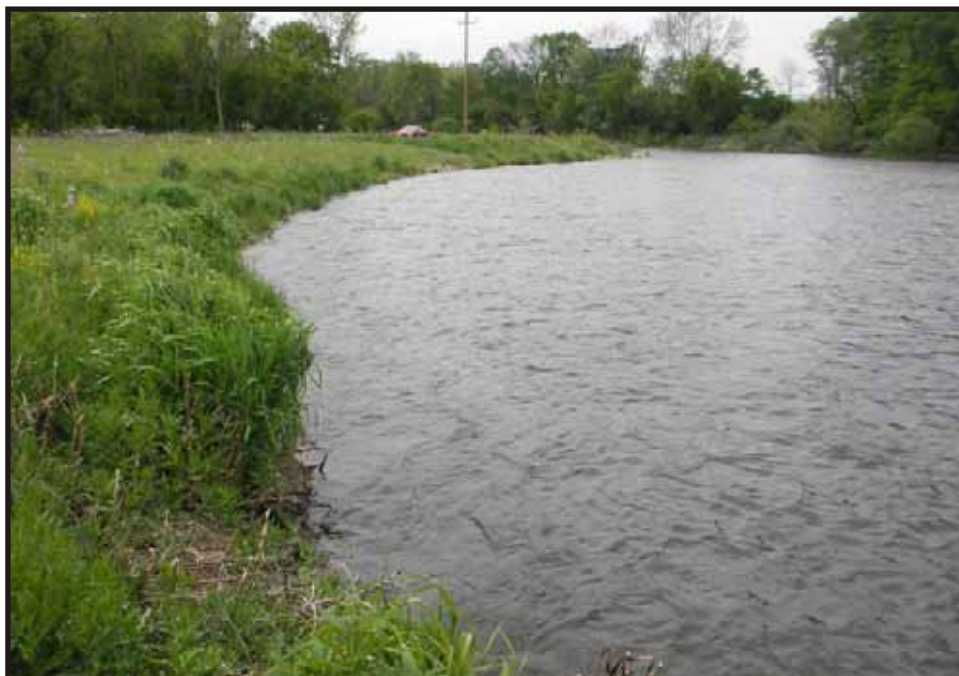
22

Photo #22: BEHI Area N1 (High Erosion Potential) on south bank downstream of the US-131 bridge, looking northwest.

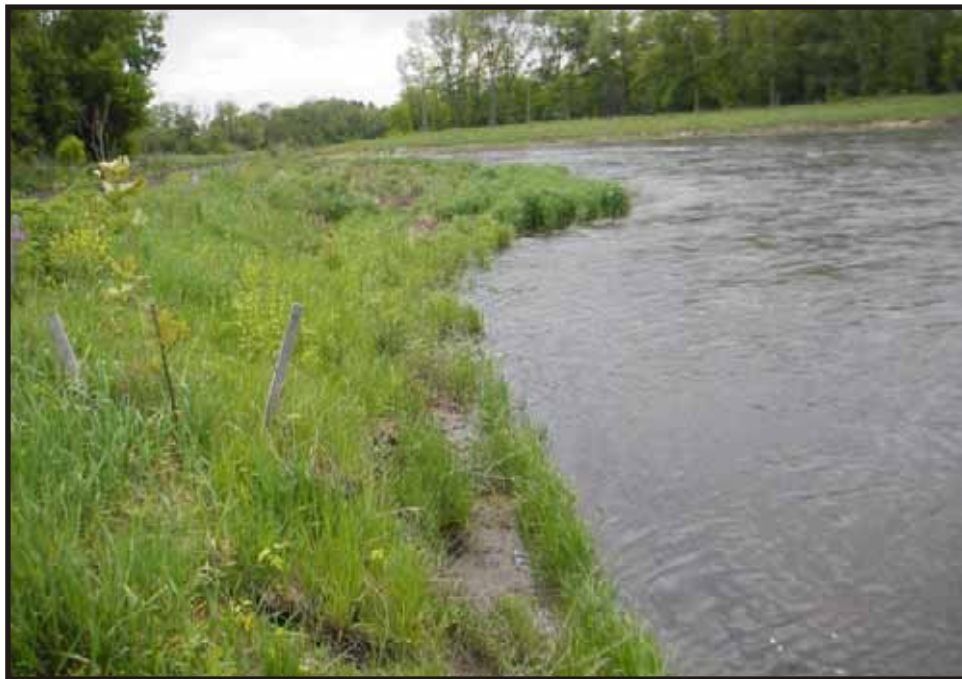
24

Photo #24: BEHI Area J2 (Low Erosion Potential) on south bank downstream of the US-131 bridge, looking southwest.

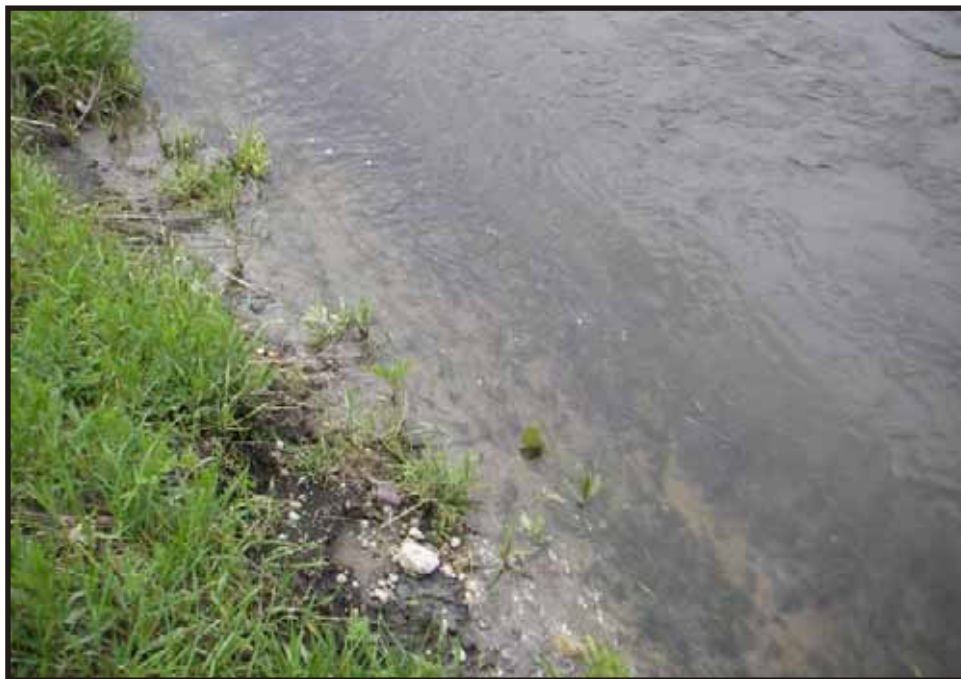
25

In 2009, a portion of the south bank upstream of the former Plainwell Dam at the former locations of Removal Areas 8B and 9B were concluded to require repair due to excessive erosion. The repairs implemented in fall 2009 consisted of placing river run rock from the remaining top-of-bank shelf to the river bed at an approximate 2:1 (horizontal:vertical) slope. The rock placement was similar to the bank repair performed in Removal Area 7, where rock was placed using a long reach excavator from the south bank. In addition to the rock toe protection, the remaining portions of the shelf behind (landward) the rock were provided additional erosion protection by the installation of a coir log at the prism-out median water elevation, which is the interface of the rock toe protection and the shelf. The coir log is functioning to reduce the flood frequency to allow the establishment and protection of vegetation on the shelf to further stabilize the shelf. This repair resulted in an increase in surface protection which decreased the BEHI rating for the repaired portion of bank (Labeled J2 on Figure 11) from Moderate to Low.

Photo #25: BEHI Area J2 (Low Erosion Potential) on south bank repaired in 2009 with rock and coir log.

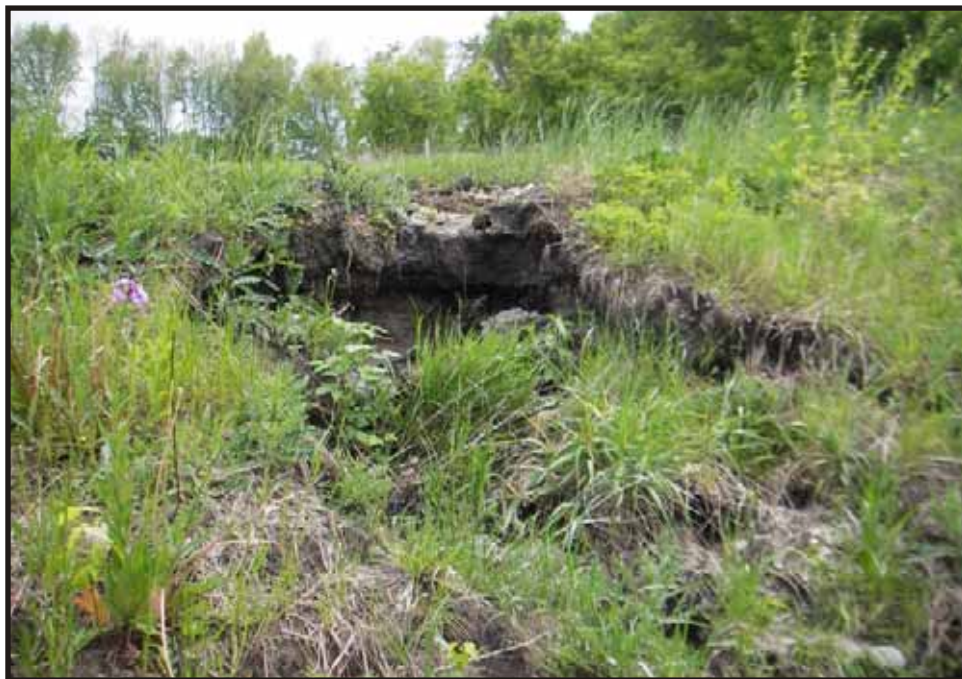
35

Photo #35: Collapsed top of south bank opposite former southern staging area.
